ATKINS

# Rock Slope Engineering

# Project Experience

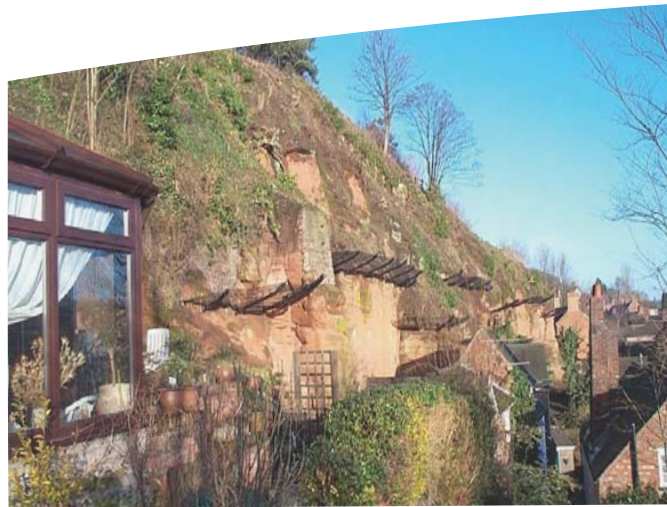
The incidence of several rockfalls onto residential and commercial properties at the foot of a sandstone cliff prompted Bridgnorth District Council to appoint Atkins to inspect the cliff face and assess its stability. The cliff is some 20 to 25m high. Its lower section stands vertically and contains a number of man-made caves, which have been used as residential dwellings and for commercial storage.

Following a detailed investigation of the problem, we designed a steel catch-fence which was anchored to the cliff face using rock dowels. Other remedial works included dowelling of potentially loose blocks of rock and removal of an unstable rock pillar, all carried out using roped access techniques under Atkins' supervision.

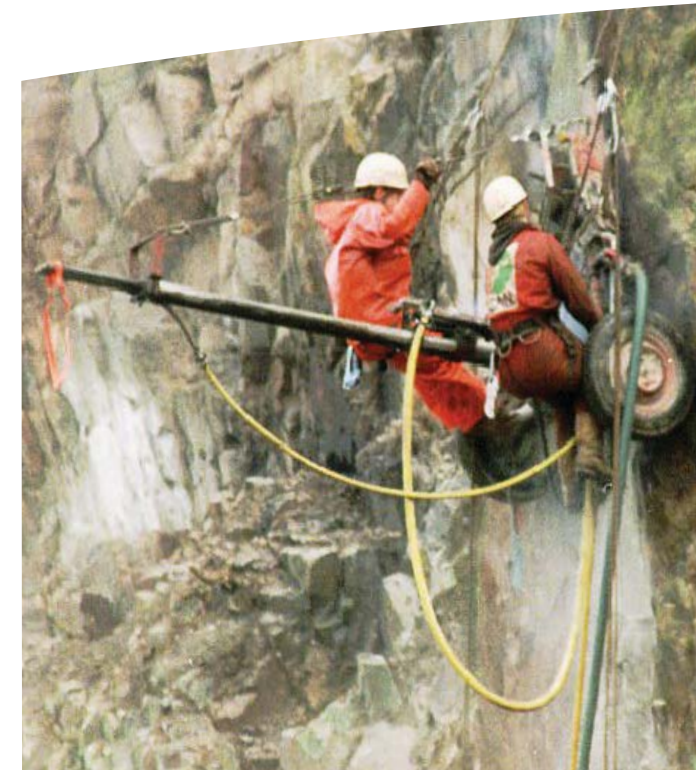
Morely Quarry is an abandoned quarry excavated in Pre-Cambrian volcanic rocks. There have been falls of material from the quarry faces, which are up to 18m high and have slope angles of 80°. We were commissioned to assess the stability of the quarry faces and then identify, design and supervise the implementation of remedial measures to mitigate risks to visiting students and others who require access to the faces.
